# **Erosion & Sedimentation Control Law**

A report to the  
121st Maine Legislature

Cumberland and Kennebec County Soil and Water Conservation Districts compiled this report under the direction of the Maine Department of Environmental Protection

January 2004

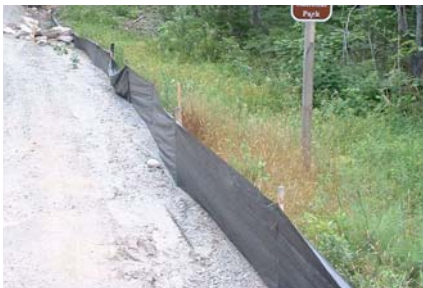
Silt fence

The picture at left shows **silt fence** that has been properly “keyed in”, which requires digging a trench, inserting the toe of the silt fence in the trench, and then backfilling.

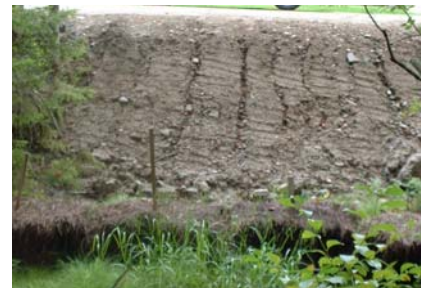
Hay bales

Properly installed **hay bales** should be placed in a trench, backfilled, and then secured in place with stakes.

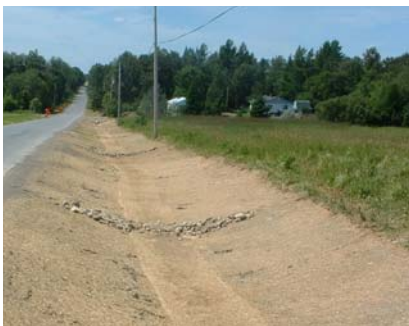
This picture shows a roadside ditch that has been lined with temporary mulch.

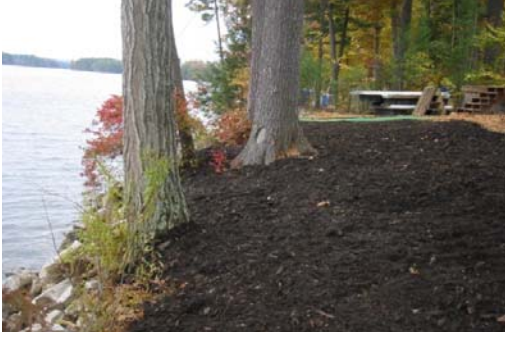
Erosion control mulch is applied here as a permanent mulch that will be a long-term cover to provide good buffer around a disturbed area.

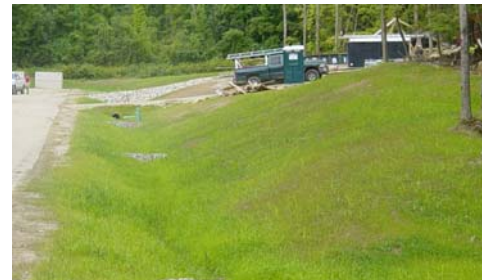
This ditch has been lined with grass to provide a permanent vegetative cover.

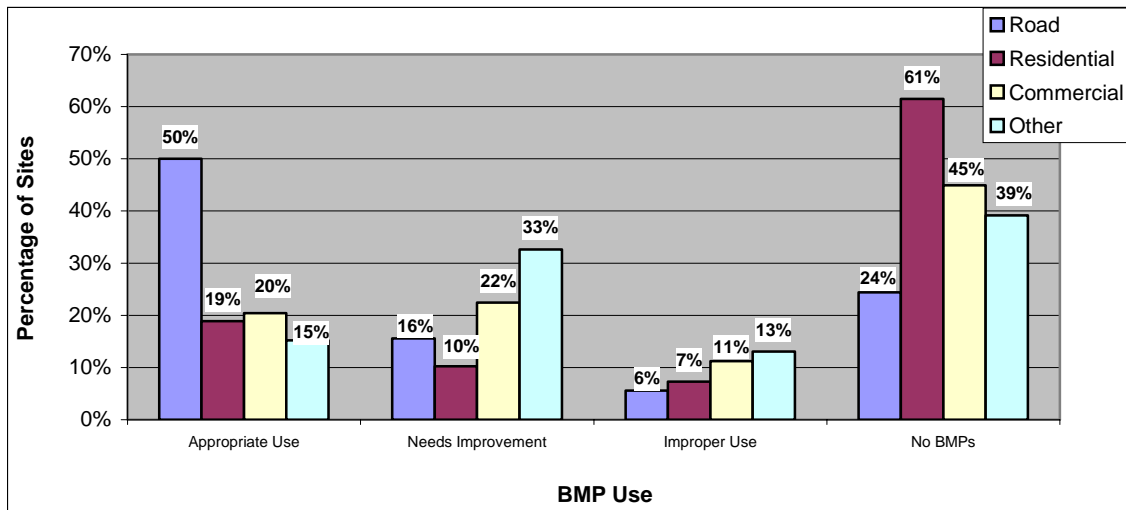
### Construction Type

- Road sites (50%) were more likely to have used BMPs and used them correctly, then the other types of surveyed sites.
- BMPs were least likely to be used on residential sites; 61% of these sites had no BMPs in place.

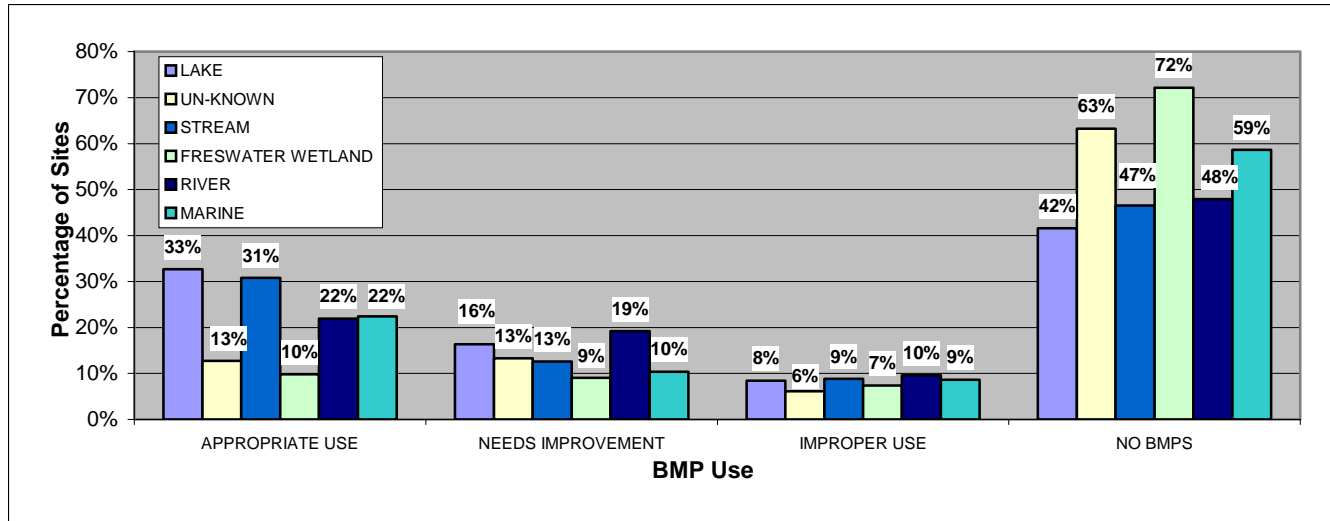
## Watershed Type

- The type of natural resource watershed that sites were located in varied, as can be seen in the pie chart at right.

- There were a higher percentage of sites without any BMPs found on sites that were near a freshwater wetland (72%) or where the natural resource was unknown (63%).

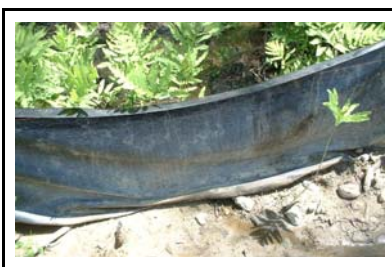
Pictured at left is an improperly installed silt fence. The bottom four inches of the fence should have been "keyed in," such that a trench should have been dug out, the toe of the fence installed in the trench, and then backfilled.

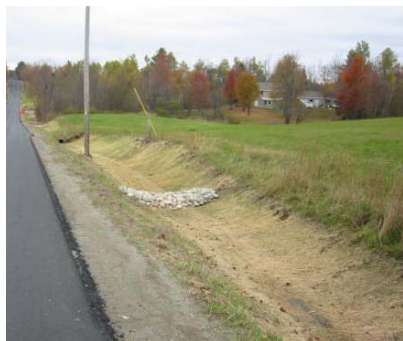
## Compliance

- Ditches are designed to carry water, so they are sloped to convey water.
- The ditch pictured at left has temporary check dams and mulch to prevent erosion.
- Thus, measures have been taken to prevent unreasonable erosion of soil or sediment into a protected natural resource, which makes this site compliant with the E&SC law.

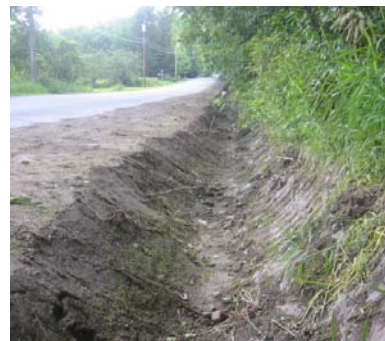
## Non Compliance

- Ditches are designed to carry water, so they are sloped to convey water.
- The ditch pictured at right does not have any BMPs in place.
- Thus, no measures have been taken to prevent unreasonable erosion of soil or sediment into a protected natural resource, so this site is noncompliant with the E&SC law.

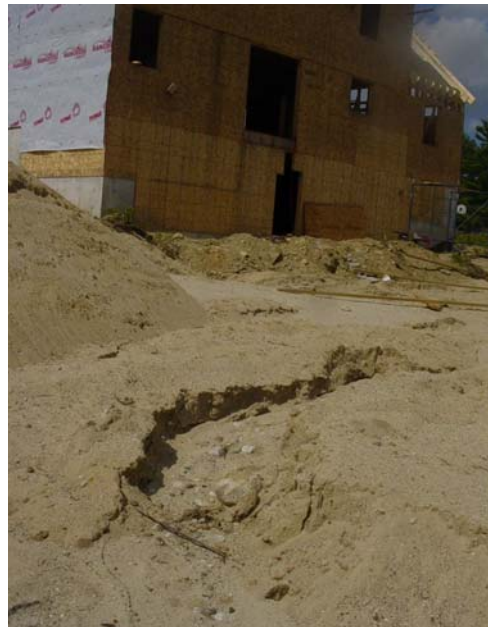
The picture at right depicts a common scene throughout Maine—soil eroding off a residential development site.

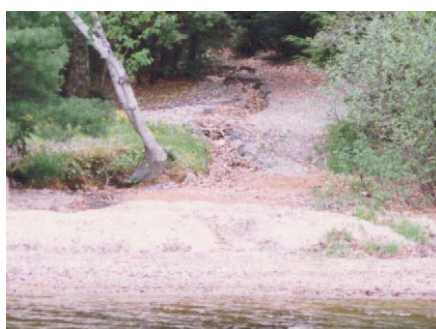
## Typical chronic erosion site

This is steeply sloped private, gravel road that dead ends into a boat launch to a lake. The gullies pictured here are a typical scene every spring. Also typical are the multiple loads of gravel that are applied each year to make this road accessible to the homeowners.

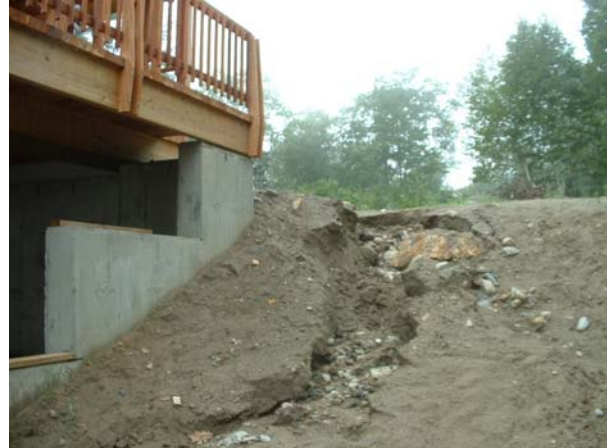
Residential site with no BMPs in place—a typical scene throughout Maine.
